NASA/TP-97-206257

The Characteristics of Fatigue Damage in the Fuselage Riveted Lap Splice Joint

Robert S. Piascik
Langley Research Center, Hampton, Virginia

November 1997

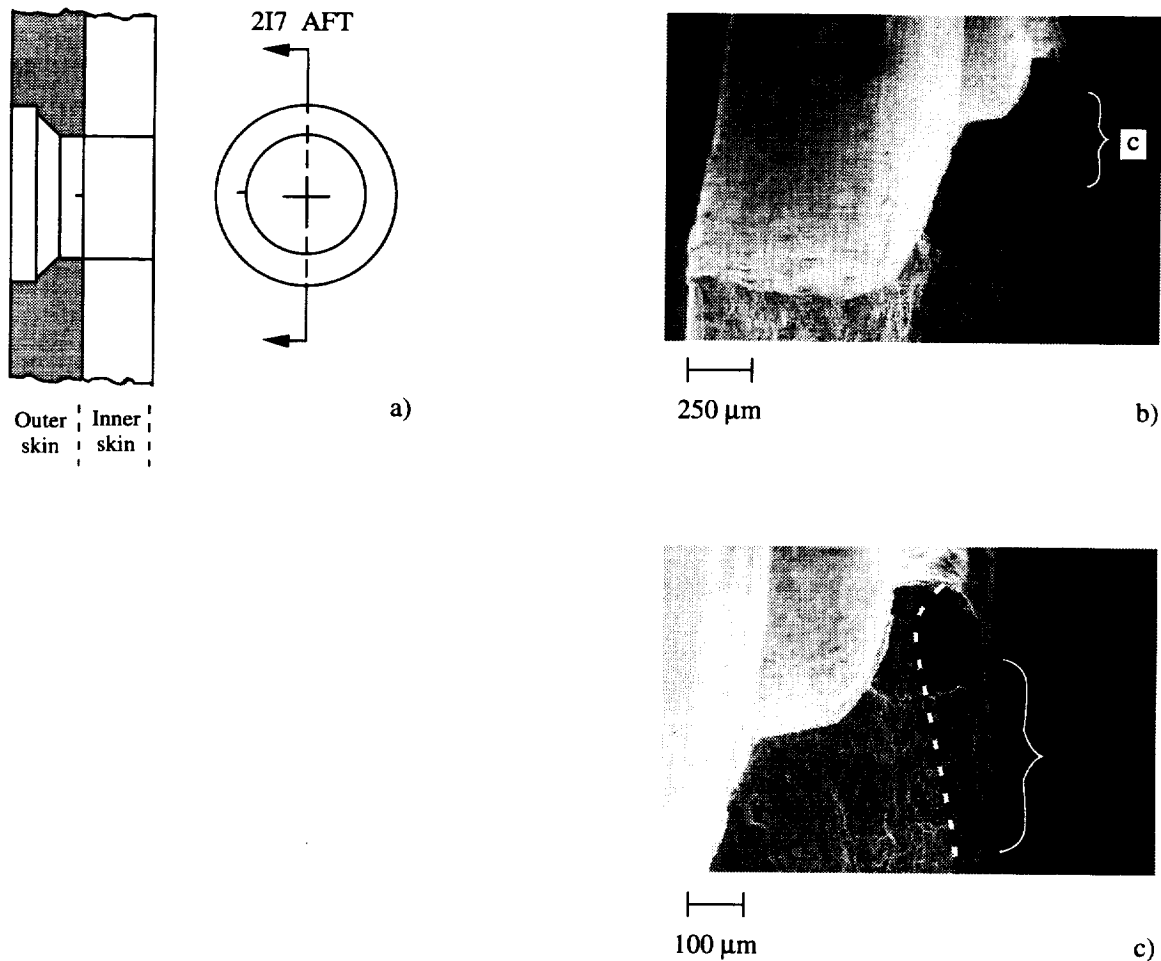
Figure 7.25 a) The schematic shows the rivet hole 217 configuration and the location of the outer skin fatigue crack oriented in the aft direction and about the 9 o'clock position. b) The SEM micrograph shows the fatigue crack along the faying surface. The bracket marks the region of crack initiation along the faying surface. Note the rivet hole shank region exhibits an anomalous configuration. c) The SEM micrograph shows the fatigue crack (region "c" in Figure 7.25.b) at high magnification. The dashed line marks the fatigue crack front. The bracket marks the region of crack initiation along the rough faying surface.

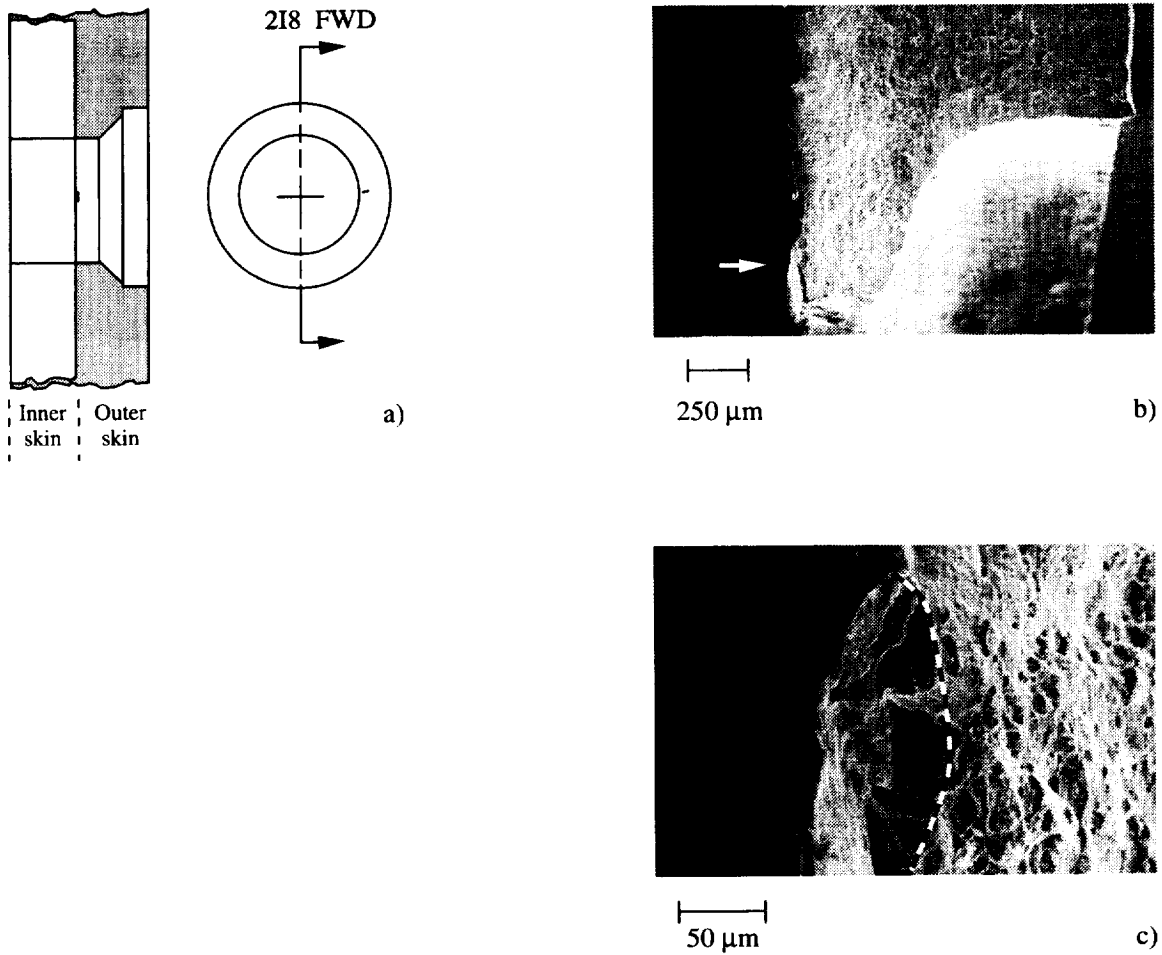
Figure 7.26 a) The schematic shows the rivet hole 2I8 configuration and the location of the outer skin fatigue crack oriented in the forward direction and about the 3 o'clock position. b) The SEM micrograph shows a small fatigue crack (marked by the arrow) located at the faying surface c) The SEM micrograph shows the small fatigue crack contained in the clad layer at high magnification. The dashed line marks the fatigue crack front. The crack initiated in a roughened surface region at the faying surface.

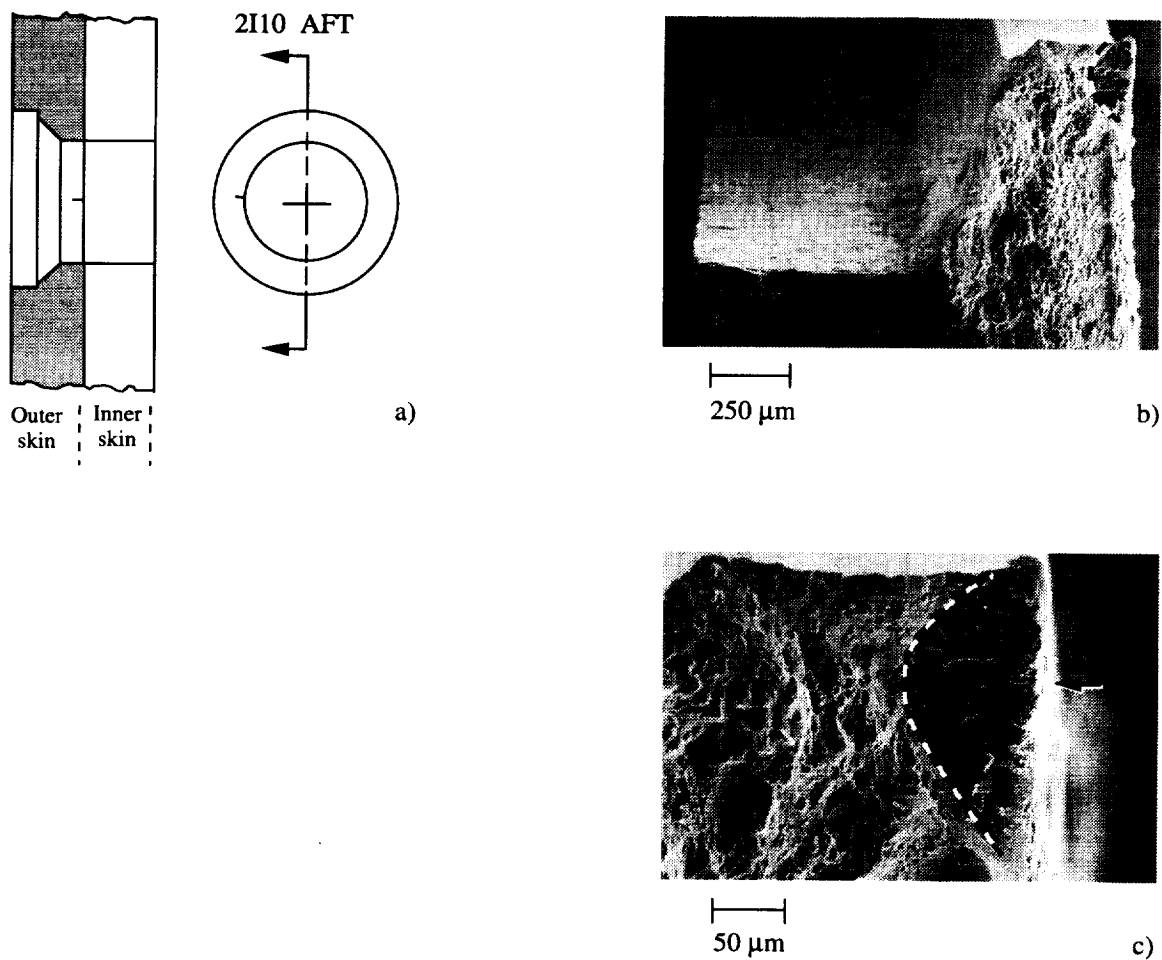
Figure 7.27 a) The schematic shows the rivet hole 2I10 configuration and the location of the outer skin fatigue crack oriented in the aft direction and about the 9 o'clock position. b) The SEM micrograph shows a small fatigue crack located at the rivet hole shank region along the faying surface. The dashed line marks the fatigue crack front. c) The SEM micrograph shows the small fatigue crack at high magnification. The dashed line marks the fatigue crack front. The crack initiated in a roughened region along the faying surface.

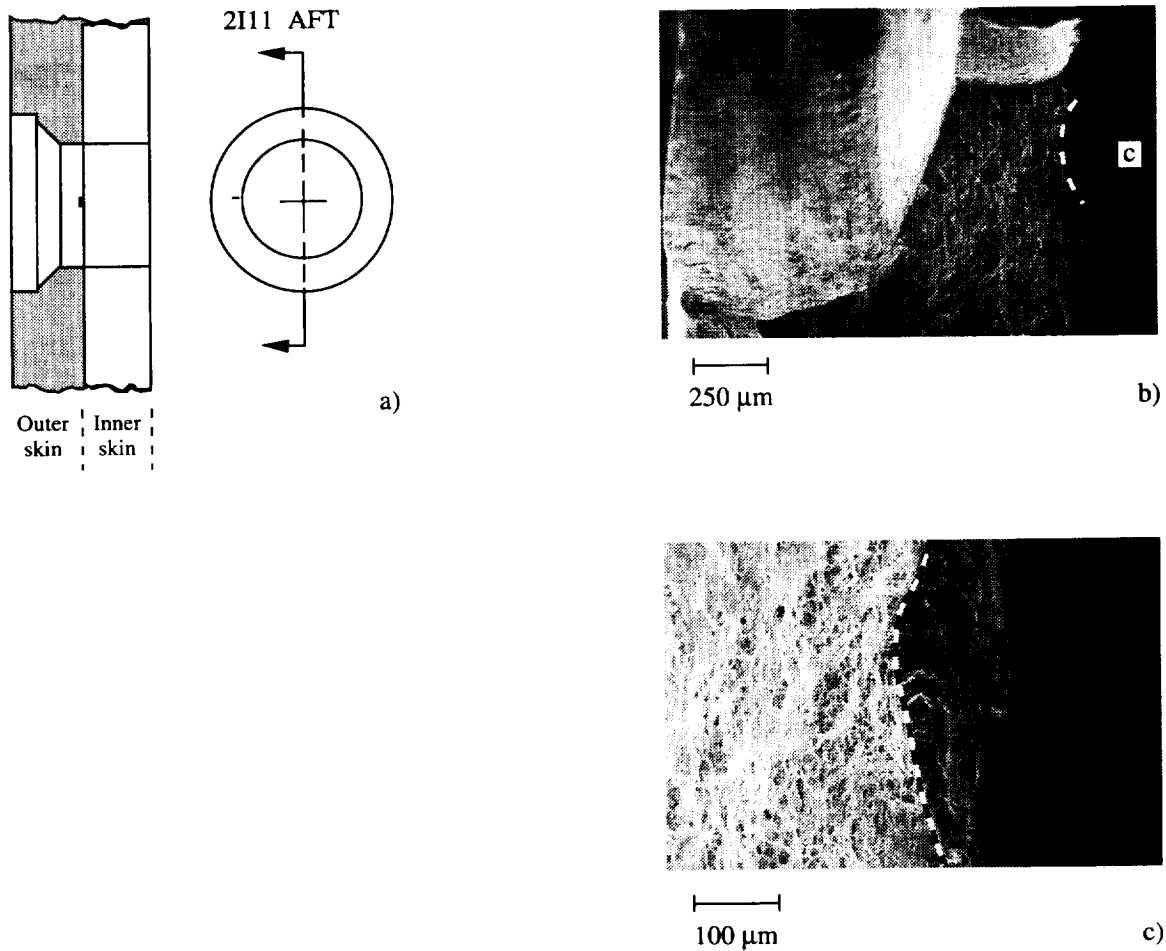
Figure 7.28 a) The schematic shows the rivet hole 2I11 configuration and the location of the outer skin fatigue crack oriented in the aft direction and about the 9 o'clock position. b) The SEM micrograph shows a small elongated fatigue crack located at the faying surface. The dashed line marks the fatigue crack front. c) The SEM micrograph shows the small fatigue crack contained in the clad layer at high magnification, region "c" in Figure 7.28.b. The dashed line marks the fatigue crack front. The crack initiated in a roughened region along the faying surface.

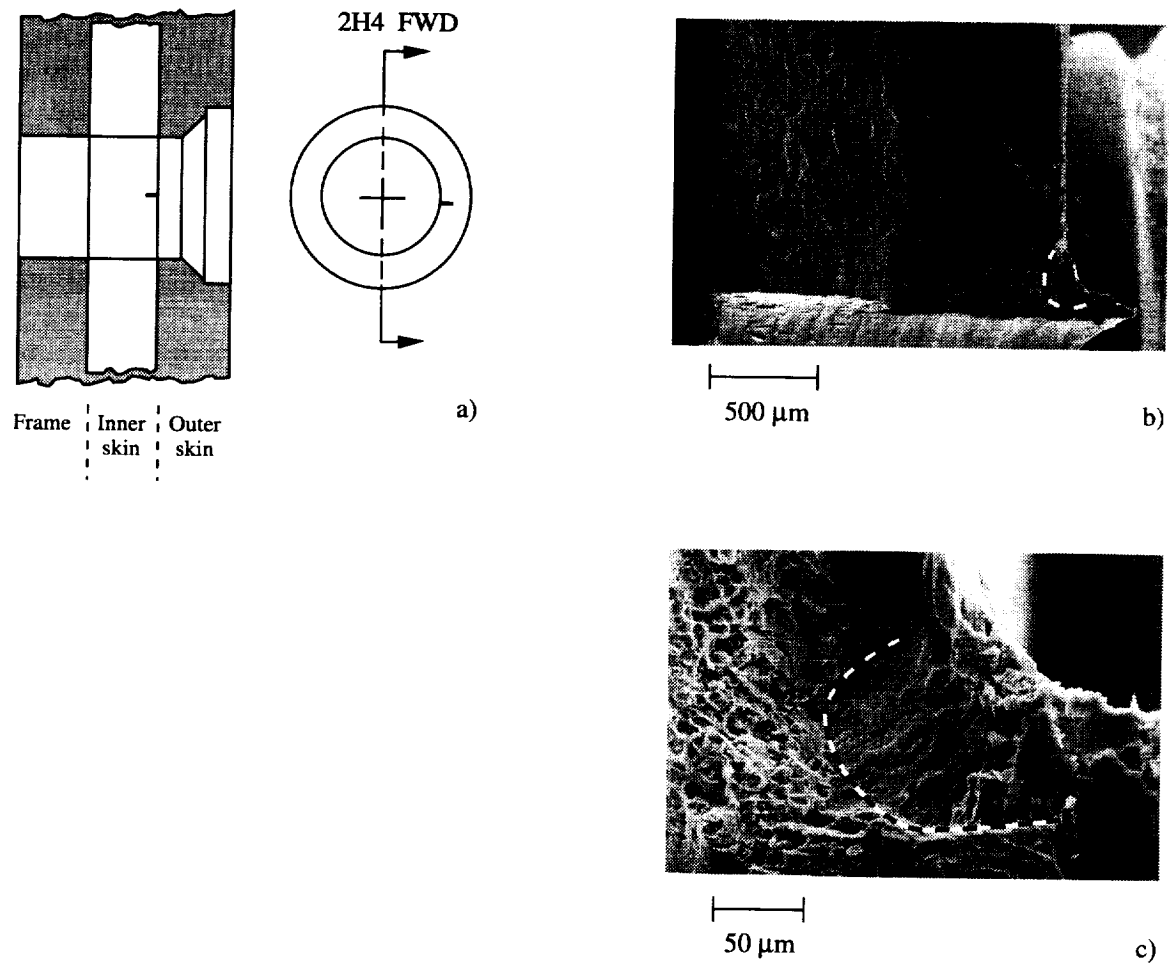
Figure 7.29 a) The schematic shows the rivet hole 2H4 configuration and the location of the inner skin fatigue crack oriented in the forward direction and about the 3 o'clock position. b) The SEM micrograph shows a small fatigue crack located near a rivet hole corner burr. The dashed line marks the fatigue crack front. c) The SEM micrograph shows the small fatigue crack at high magnification.

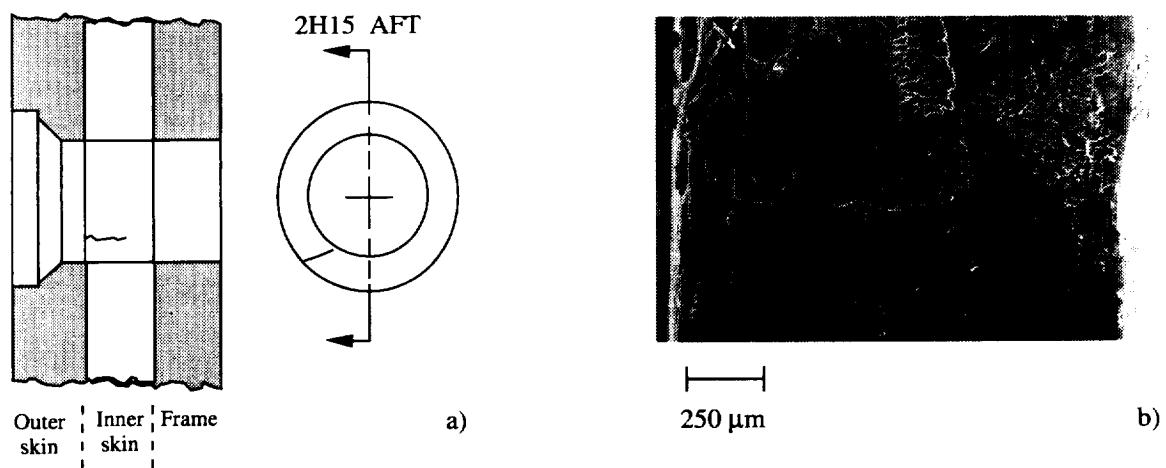
Figure 7.30 a) The schematic shows the rivet hole 2H15 configuration and the location of the inner skin fatigue crack oriented in the aft direction and below the 8 o'clock position. b) The SEM micrograph shows the inside surface of the rivet hole and a fatigue crack extending from the outboard corner. The crack was partially opened during the destructive examination. SEM examination into the partially opened corner crack verified that the crack was a transgranular fatigue crack.

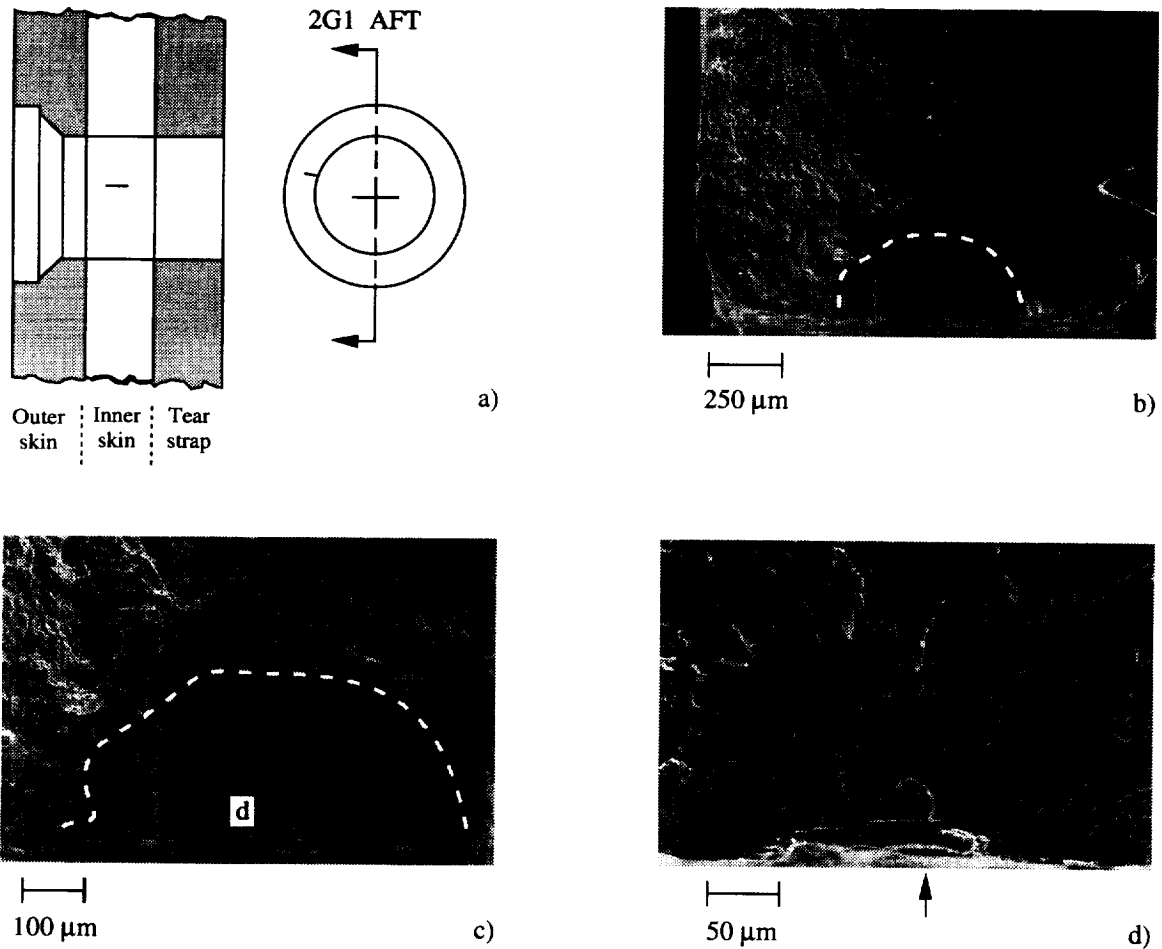
Figure 7.33 a) The schematic shows the rivet hole 2G1 configuration and the location of the inner skin fatigue crack oriented in the aft direction and above the 9 o'clock position. b) The SEM micrograph shows the fatigue crack at the mid-thickness location of the inner skin rivet hole (bottom of the micrograph). The dashed line marks the fatigue crack front. c) The SEM micrograph shows the semicircular shaped surface fatigue crack at higher magnification. The dashed line marks the fatigue crack front. d) The SEM micrograph shows the crack initiation region (region "d" in Figure 7.33.c). The region of crack initiation marked by an arrow along the inside surface of the rivet hole exhibits disturbed metal.

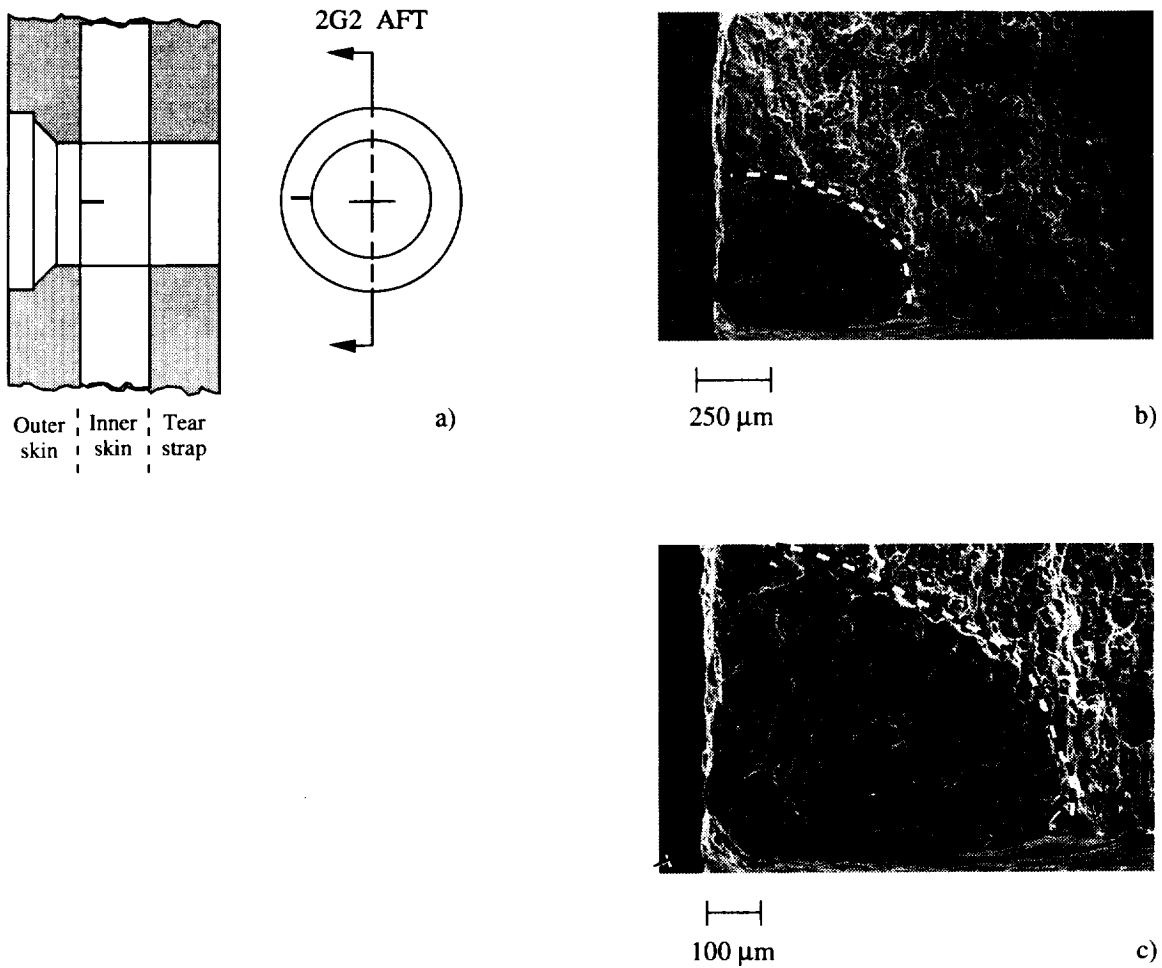
Figure 7.34 a) The schematic shows the rivet hole 2G2 configuration and the location of the inner skin fatigue crack oriented in the aft direction and at the 9 o'clock position. b) The SEM micrograph shows the fatigue crack fracture surface located at the outboard corner of the rivet hole (bottom-left of the micrograph). The dashed line marks the fatigue crack front. c) The SEM micrograph shows the corner fatigue crack at higher magnification. The arrow marks the region of crack initiation and the dashed line marks the fatigue crack front.

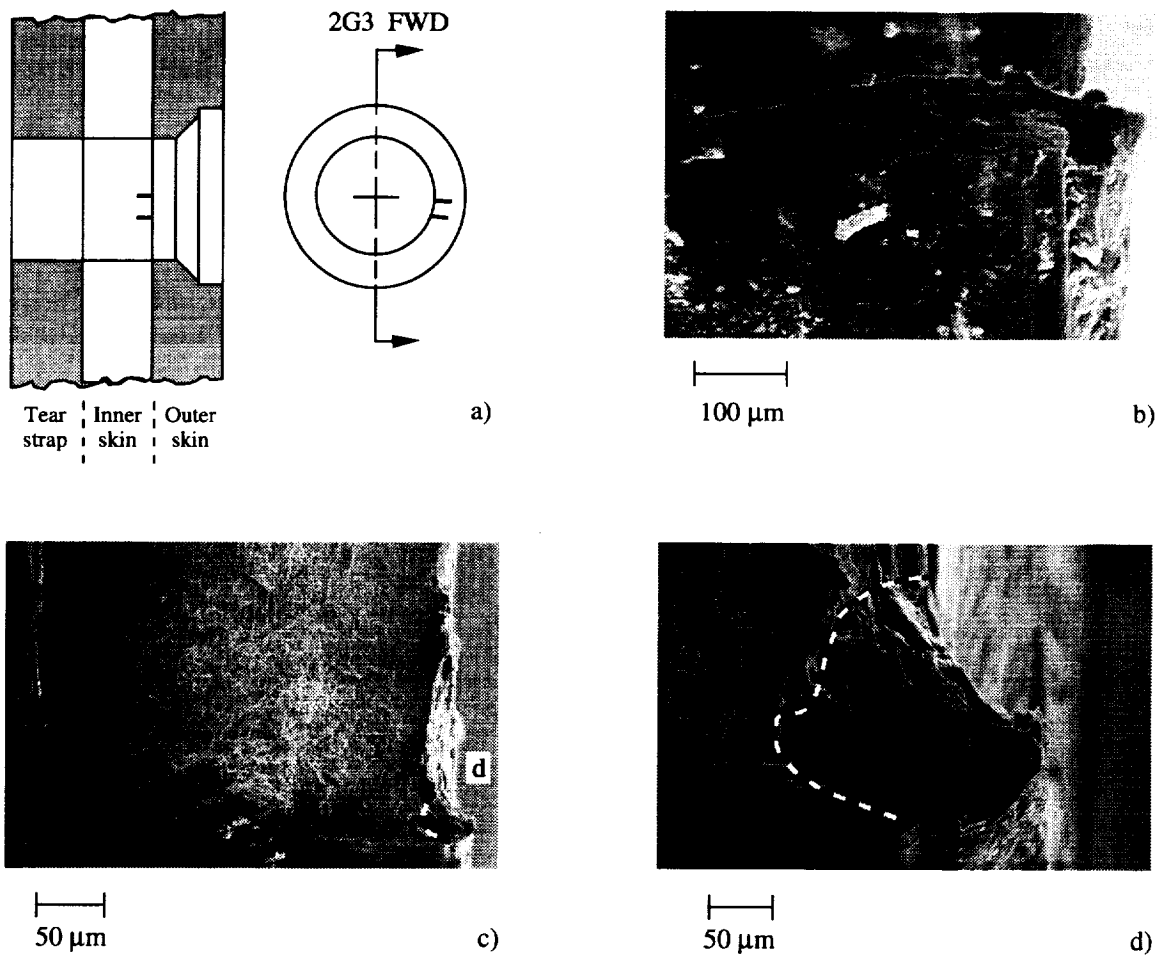
Figure 7.35 a) The schematic shows the rivet hole 2G3 configuration and the location of two inner skin fatigue cracks oriented in the forward direction and slightly below the 3 o'clock position. b) The SEM micrograph shows the surface of the rivet hole and a partially opened fatigue crack at the outboard corner after the initial destructive examination straining operation. A burr and disturbed metal are observed at the corner. c) The SEM micrograph shows the corner fatigue crack surface at the outboard corner of the rivet hole. The dashed line marks the fatigue crack front. d) The SEM micrograph shows the corner fatigue crack at high magnification (region "d" in Figure 7.35.c). The region of crack initiation is located near disturbed metal produced by a corner burr.

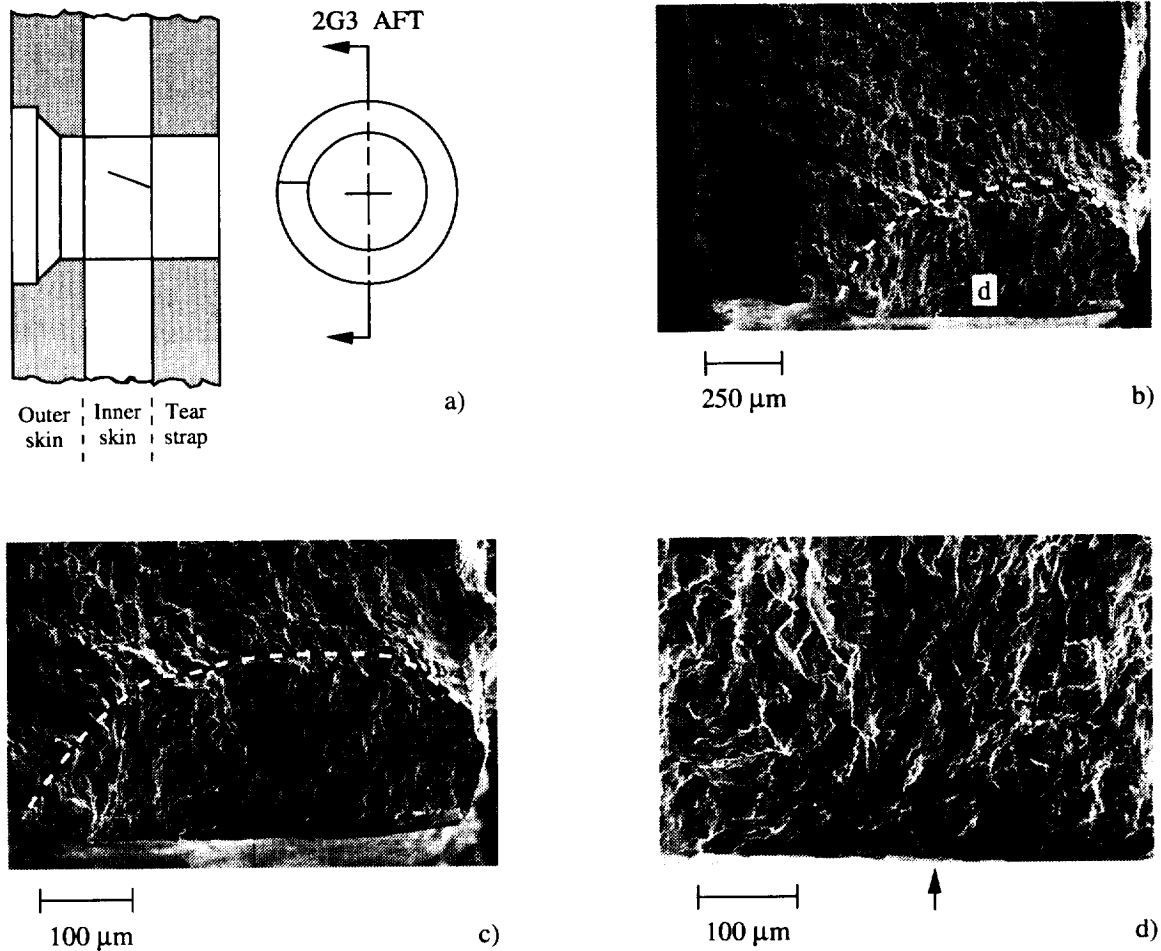
Figure 7.36 a) The schematic shows the rivet hole 2G3 configuration and the location of the inner skin fatigue crack oriented in the aft direction and about the 9 o'clock position. b) The SEM micrograph shows the fatigue crack located along the rivet hole (bottom of the micrograph). The dashed line marks the fatigue crack front. c) The SEM micrograph shows the fatigue crack surface at higher magnification. The dashed line marks the fatigue crack front. d) The SEM micrograph shows the fatigue crack along the rivet hole inside surface (region "d" in Figure 7.36.b). The arrow marks the likely site of crack initiation.

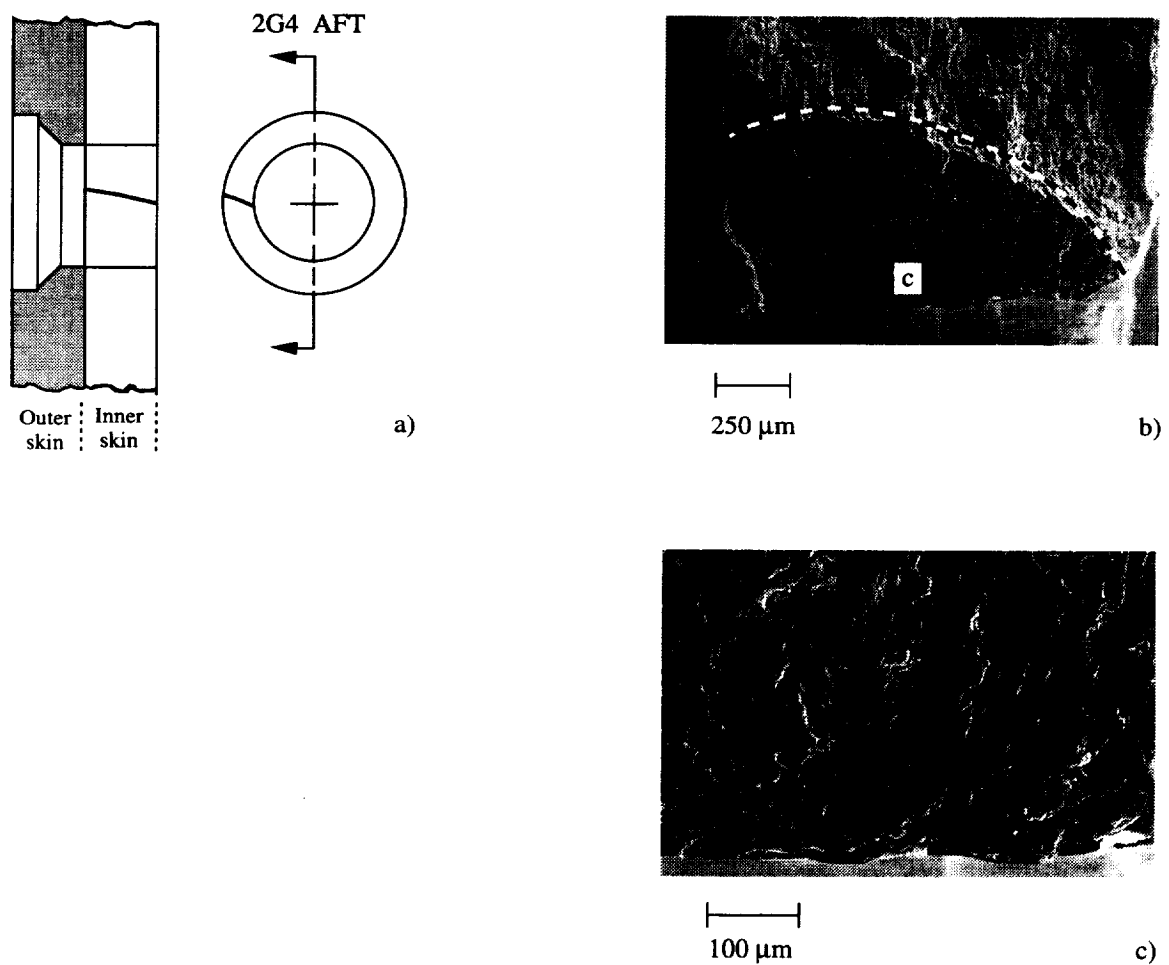
Figure 7.37 a) The schematic shows the rivet hole 2G4 configuration and the location of the inner skin fatigue crack oriented in the aft direction and about the 9 o'clock position. b) The SEM micrograph shows the fatigue crack fracture surface located along the rivet hole (bottom of micrograph). The fatigue crack extends nearly through the thickness of the inner skin. The dashed line marks the fatigue crack front. c) The SEM micrograph shows the rough surface of the rivet hole and the likely site of crack initiation (region "c" in Figure 7.36.b).

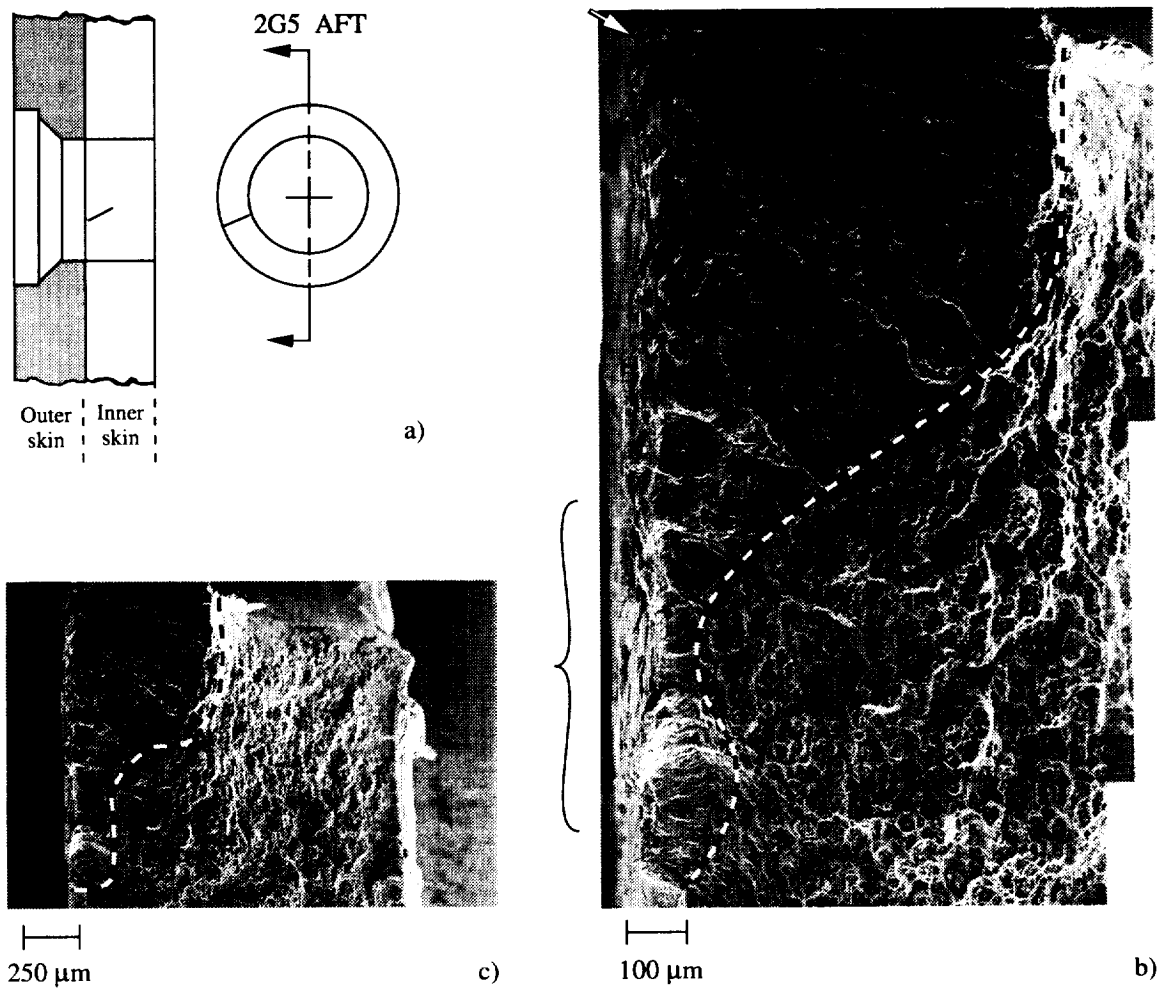
Figure 7.38 a) The schematic shows the rivet hole 2G5 configuration and the location of the inner skin fatigue crack oriented in the aft direction and slightly below the 9 o'clock position. b) The SEM micrograph shows the fatigue crack fracture surface that extends along the faying surface (left of micrograph). The rivet hole is located at the top of the micrograph. The dashed line marks the fatigue crack front. The crack front geometry suggests that a number of surface fatigue cracks initiated along the faying surface and have coalesced to form a nonsemicircular shaped fatigue crack front. Possible crack initiation sites are marked by an arrow at the corner and a bracket along the faying surface. c) The SEM micrograph shows the relationship of the fatigue crack surface with the rivet hole (top) and inboard skin surface. The dashed line marks the fatigue crack front.

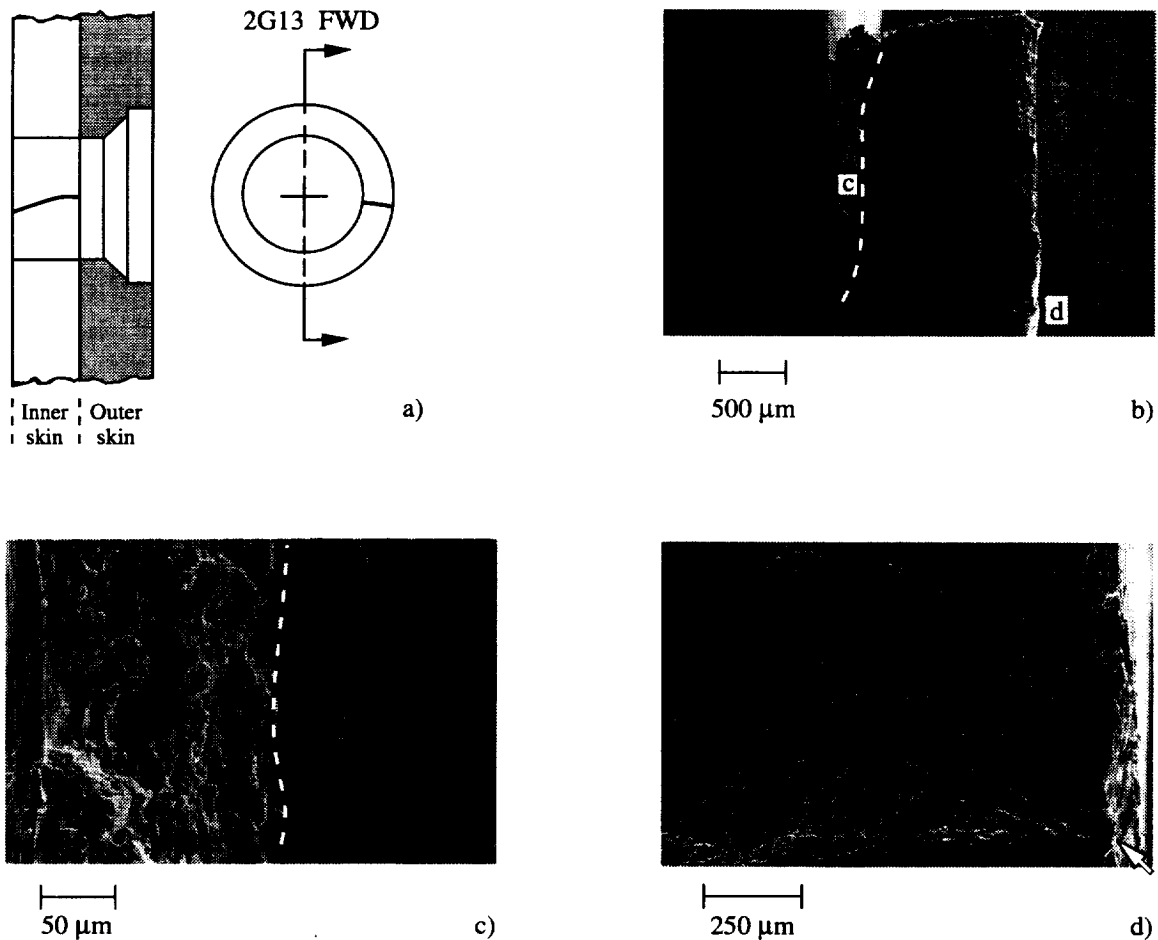
Figure 7.39 a) The schematic shows the rivet hole 2G13 configuration and the location of the inner skin fatigue crack oriented in the forward direction and about the 3 o'clock position. b) The SEM micrograph shows the fatigue crack fracture surface (the direction of crack propagation is from bottom to top of the figure) in the inner skin. The rivet hole is located at the bottom of the micrograph. The fatigue crack was cut during the removal of the specimen from the panel and a portion of the fatigue crack surface is not shown in the figure. The dashed line shows a portion of the fatigue crack front that extends nearly parallel to the inboard surface of the inner skin. c) The SEM micrograph shows the fatigue crack front region (dashed line) at region "c" in Figure 7.39.b. The fatigue fracture surface (right) exhibits a transgranular morphology while the overload fracture (left) exhibits a ductile appearance. d) The SEM micrograph region shows the outboard corner of the rivet hole (region "d" in Figure 7.39.b) at higher magnification. The arrow marks the likely site of crack initiation. The faying surface is located along the right side of the micrograph and the rivet hole is located at the bottom.

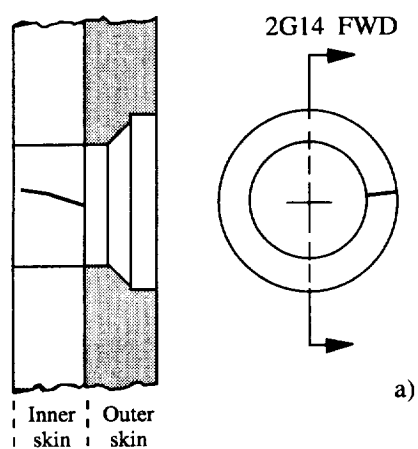
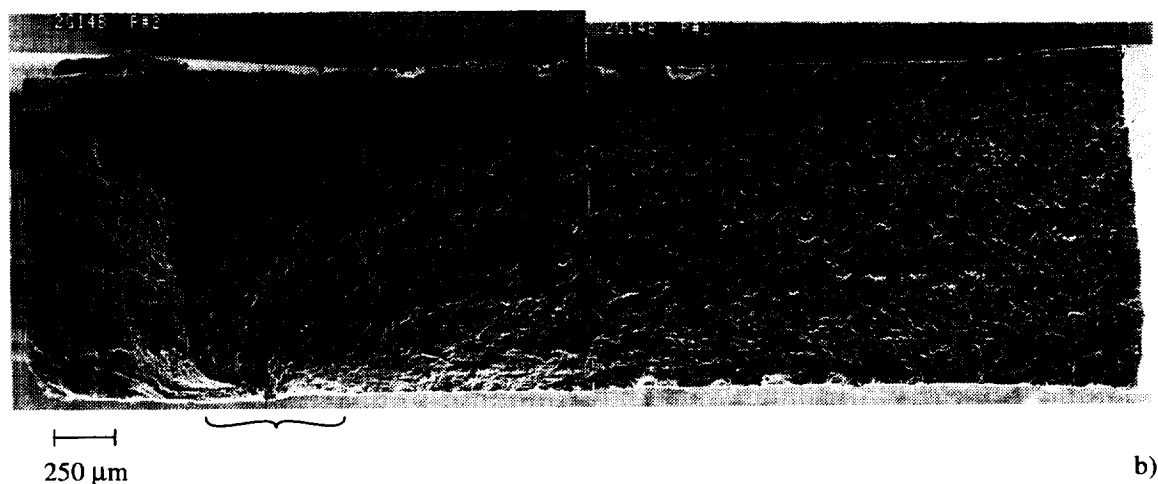
Figure 7.40 a) The schematic shows the rivet hole 2G14 configuration and the location of the inner skin fatigue crack oriented in the forward direction and about the 3 o'clock position. b) The SEM micrograph shows the fatigue crack that grew (the general direction of crack propagation is left to right) from the inner skin rivet hole which is located at the left of the micrograph. The fatigue crack was cut during the removal of the specimen from the panel and a portion of the fatigue crack surface is not shown in the figure. The fatigue crack initiated at the outboard corner of the rivet (bracket) hole at the faying surface (bottom left region of the micrograph).

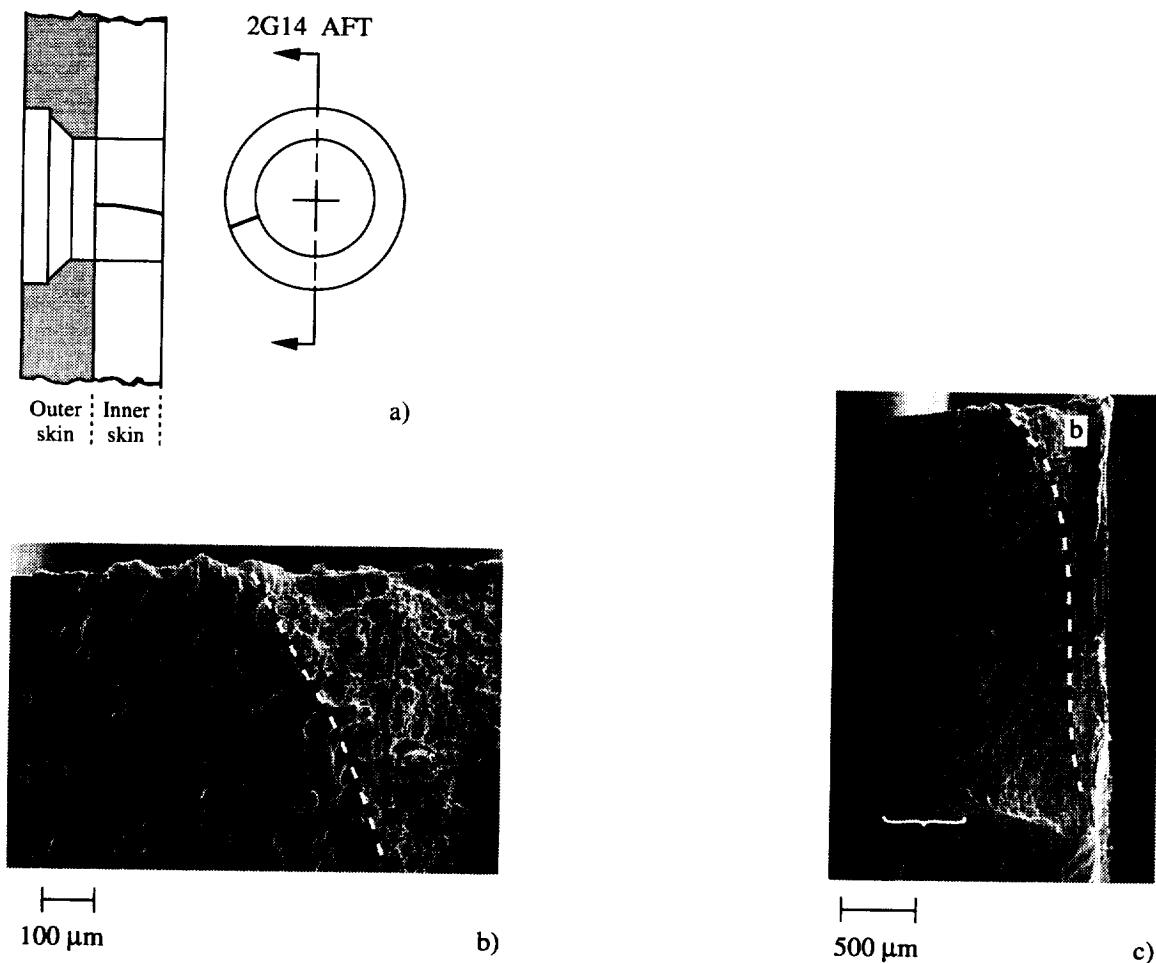
Figure 7.41 a) The schematic shows the rivet hole 2G14 configuration and the location of the inner skin fatigue crack oriented in the aft direction and below the 9 o'clock position. b) The SEM micrograph shows a portion of the fatigue crack front region (dashed line) at region "b" in Figure 7.41.c. The fatigue surface (left of the dashed line) exhibits a transgranular morphology and the overload fracture (right of the dashed line) exhibits a ductile appearance. A small portion of the fatigue crack surface is not shown in the figure. The fatigue crack was inadvertently cut during the removal of the specimen from the panel. c) The SEM micrograph shows the fatigue crack that grew (the direction of crack propagation is from bottom to top of the figure) from the inner skin rivet hole located at the bottom of the micrograph. The dashed line shows the fatigue crack front that extends nearly parallel to the inboard surface of the inner skin. A small portion of the fatigue crack surface is not shown in the figure. A bracket marks the fatigue crack initiation region.

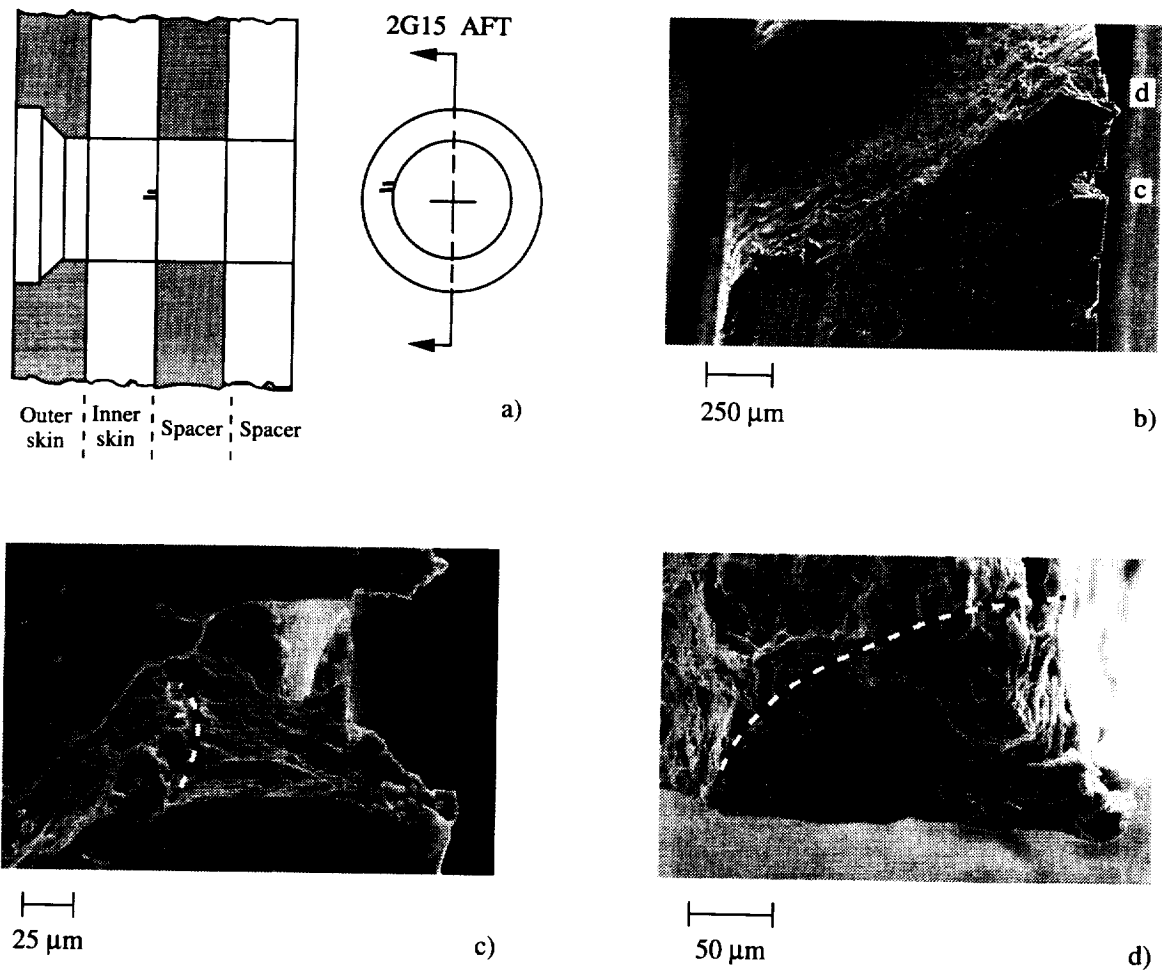
Figure 7.43 a) The schematic shows the rivet hole 2G15 configuration and the location of the inner skin fatigue crack oriented in the aft direction and about the 9 o'clock position. b) The SEM micrograph shows the rivet hole surface that has been partially fractured during the straining operation. Two fatigue cracks are noted at "c" and "d" along the outboard corner. c) The SEM micrograph shows the partially opened corner fatigue crack at region "c" in Figure 7.43.b. The dashed line marks the fatigue crack front. d) The SEM micrograph shows the corner fatigue crack at region "d" in Figure 7.43.b). The dashed line marks the fatigue crack front. The crack initiated at the burr on the corner.

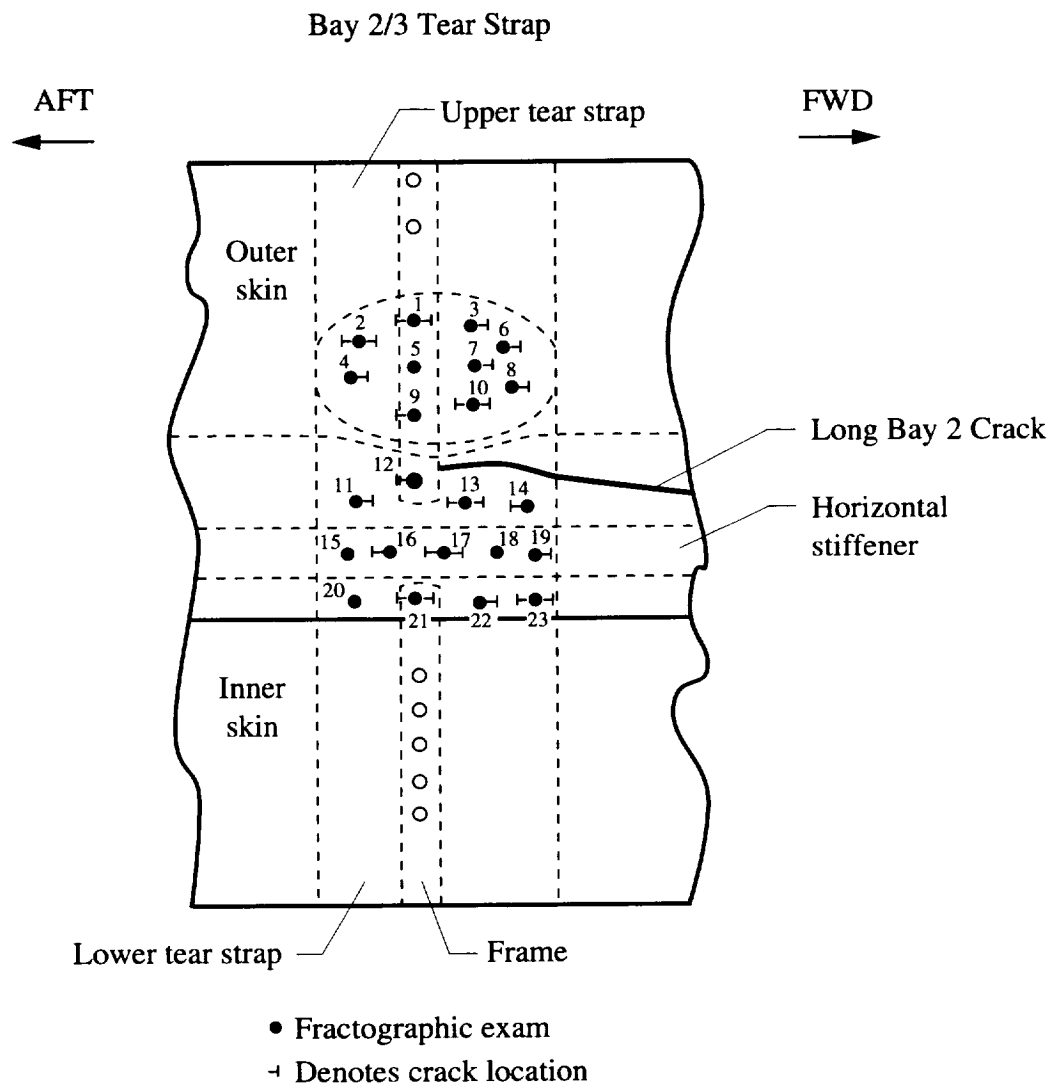
Figure 8.1 shows the bay 2/3 tear strap (T.S.) region, identifies most structural components, and locates the position of the long outer skin crack that extended into the T.S. region from bay 2. Identified in Figure 8.1 are the twenty-three rivet hole locations that were destructively examined (identified by the filled hole symbols in Figure 8.1), and the nineteen rivet hole locations that contain fatigue cracks. Figures 8.2, 8.3, 8.4 and 8.5 show the locations of thirty-one fatigue cracks observed in the outer skin, the upper tear strap and inner skin regions, the lower tear strap, and the frame, respectively. The through-thickness crack schematics shown in Figures 8.6 through 8.11 summarize location, length, type, and initiation site for all cracks found in rivet rows G through L, respectively.

Figure 8.1 The schematic shows the location of all fatigue cracks found in the bay 2/3 tear strap by destructive examination. The solid dark line depicts one end of the long bay 2 crack extending into the tear strap.

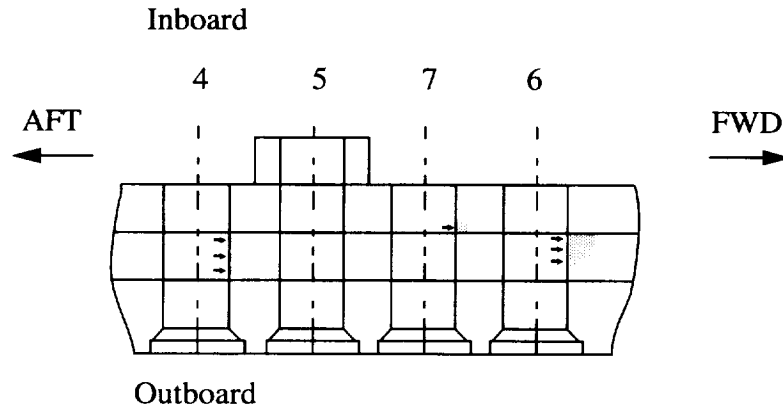
Hole #	Location	Length mm (in)	Type	Initiation site
4 (Fwd)	Upper tear strap	0.214 (0.008)	Surface	Multiple surface
6 (Fwd)	Lower tear strap	0.815 (0.032)	Corner	Surface
7 (Fwd)	Lower tear strap	0.419 (0.016)	Corner	Outboard corner

Figure 8.7 The through thickness schematic shows the location and initiation site of fatigue cracks found in holes number 4, 5, 6, and 7 in the bay 2/3 tear strap. The table summarizes crack location, crack length, crack type, and initiation site for each fatigue crack shown.

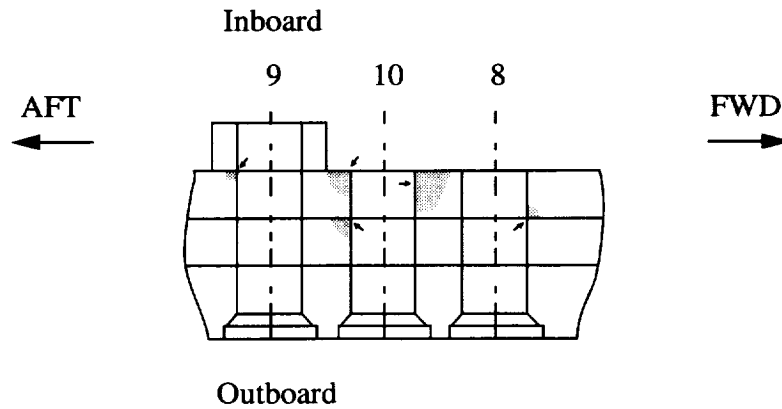
Hole #	Location	Length mm (in)	Type	Initiation site
8 (Fwd)	Lower tear strap	0.926 (0.036)	Corner	Not determined
9 (Aft)	Lower tear strap	0.143 (0.006)	Corner	Inboard Corner (IC)
10 (Aft)	Upper tear strap	0.324 (0.013)	Corner	IC
10 (Aft)	Lower tear strap	1.277 (0.057)	Corner	IC
10 (Fwd)	Lower tear strap	1.818 (0.072)	Corner	Surface

Figure 8.8 The through thickness schematic shows the location and initiation site of fatigue cracks found in holes number 8, 9 and 10 in the bay 2/3 tear strap. The table summarizes crack location, crack length, crack type, and initiation site for each fatigue crack shown.

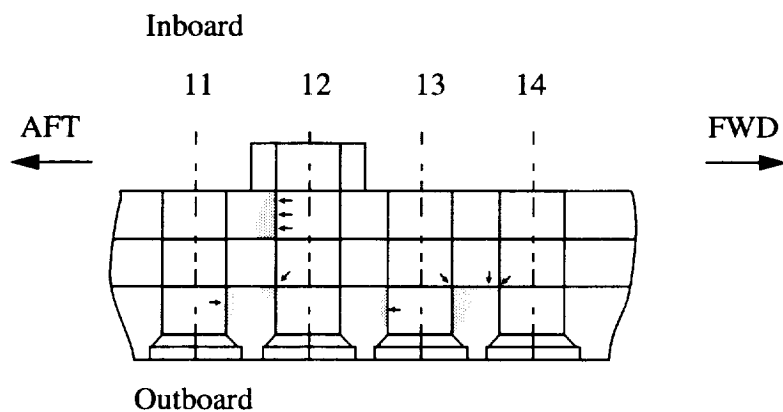
Hole #	Location	Length mm (in)	Type	Initiation site
11 (Fwd)	Outer Skin	<0.052 (<0.002)	Countersink	Center of shank
12 (Aft)	Tear strap	0.109 (0.004)	Countersink	Inboard side of shank
12 (Aft)	Inner Skin	1.190 (0.047)	Through	Multiple Surface
13 (Aft)	Outer Skin	0.214 (0.008)	Countersink	Center of shank
13 (Fwd)	Outer Skin	1.270 (0.050)	Countersink	Inboard side of shank
14 (1 Aft)	Outer Skin	0.166 (0.007)	Fretting	Inner skin / outer skin
14 (2 Aft)	Outer Skin	0.157 (0.006)	Fretting	Inner skin / outer skin

Figure 8.9 The through thickness schematic shows the location and initiation site of fatigue cracks found in holes number 11, 12, 13, and 14 in the bay 2/3 tear strap. The table summarizes crack location, crack length, crack type, and initiation site for each fatigue crack shown.
